Cura Aquarum in Israel II

Water in Antiquity

The Ancient Garden at Ramat Raḥel and its Water Installations

Boaz Gross, Yuval Gadot and Oded Lipschits

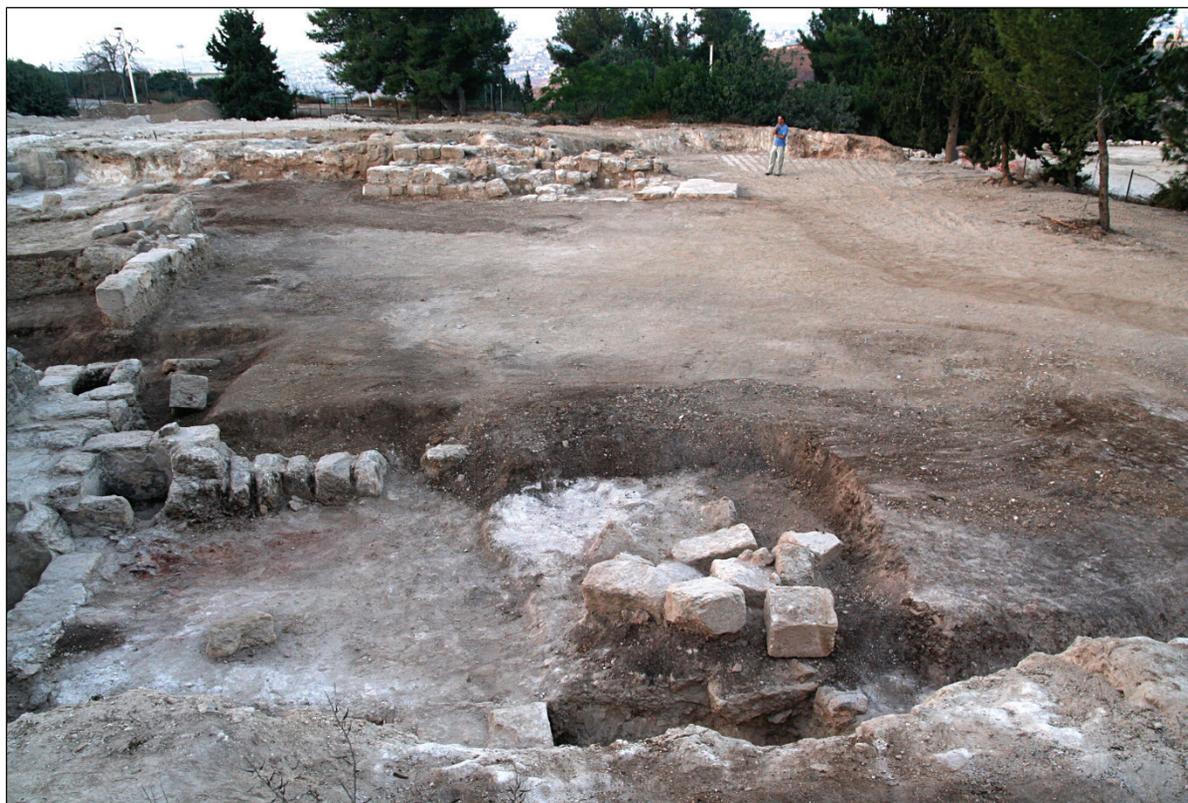
Fig. 4: Garden soil in the southwestern area, looking south (picture by Noga Cohen-Aloro).

The creation of the garden complex therefore took place during Building Phase II and its modification took place during Building Phase III. As part of the creation of the complex, an even 40-50 cm layer of dark brown soil, devoid of stones and pottery sherds, was laid on top of the smoothed limestone bedrock (fig. 4). In the northwestern part of the garden, this soil, termed by us as "garden soil", was found at the edge of Building Phase III foundation trenches (see description below) or abutting rock cut lines. It does not reach the scarp on which the tower sits. The hewing and smoothing of the rock and the laying of the garden soil were contemporaneous, and are also the earliest human activities that took place in the western part of the site. These two conclusions are further strengthened by the fact that in all but two

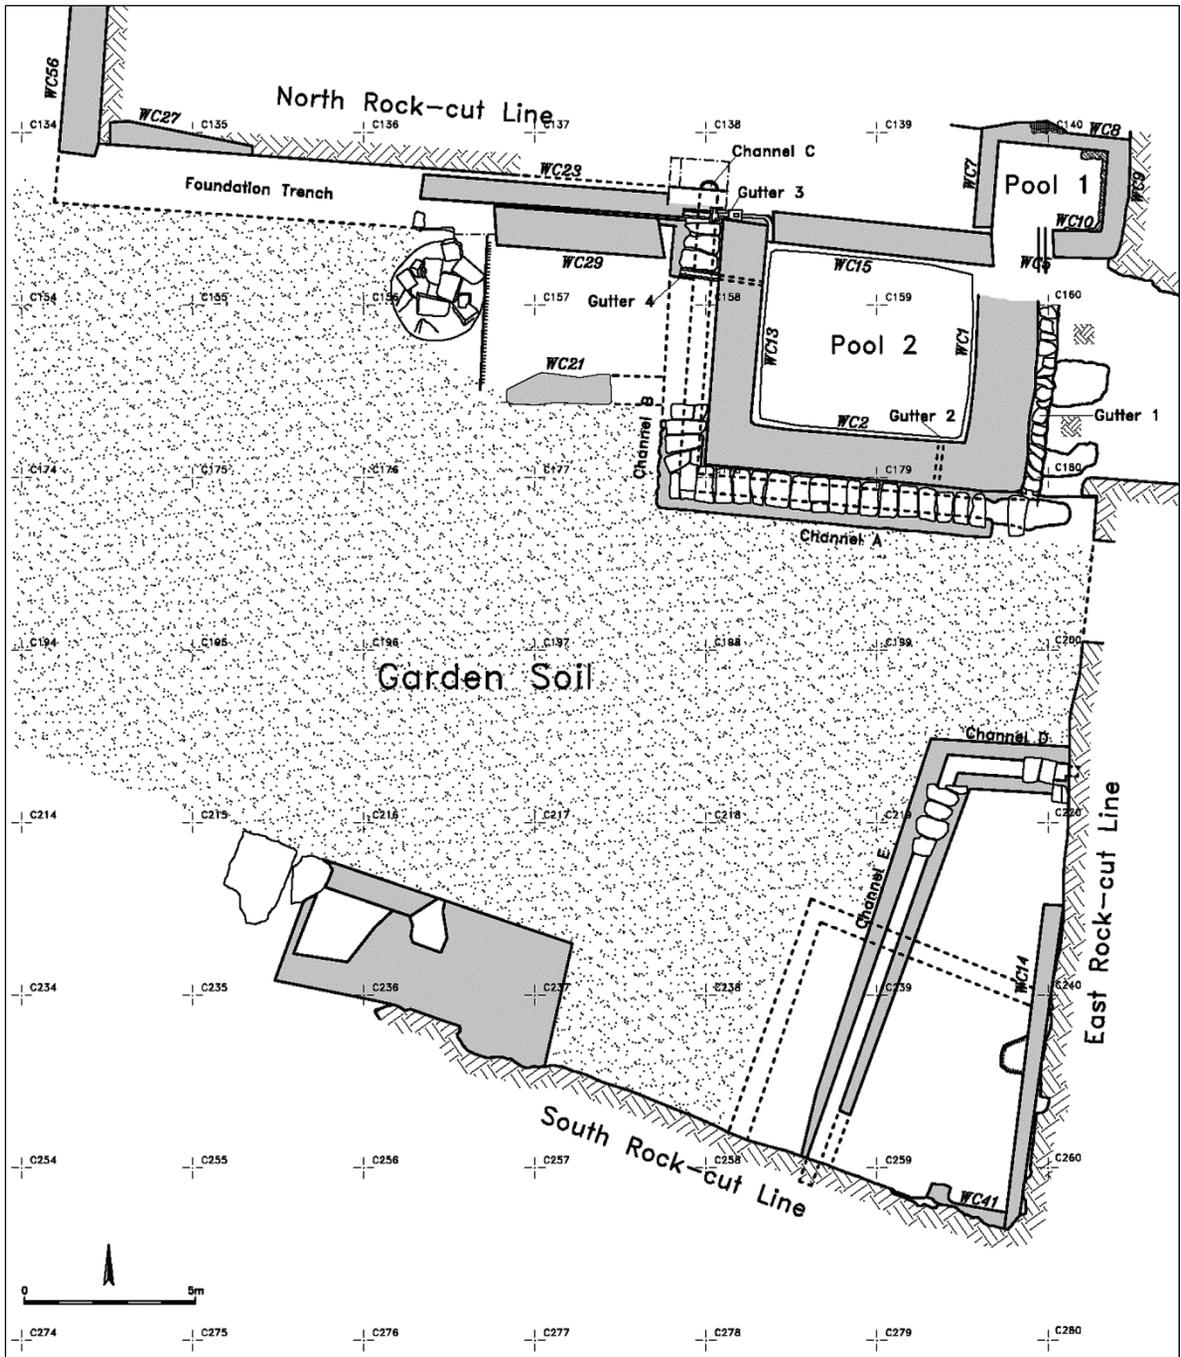
Fig. 5: Plan of the southern part of the garden (plan by Shatil Emmanuilov).

phases. The southern part of the garden (fig. 5) is dominated by a hewn, trapezoid-shaped depression, in which some of the most conspicuous water installations were found. It is our understanding that this area is the source, or beginning, of the water system and it will therefore be described first.

Channel E-D, like Channel A-C, was hewn into the rock and formed a continuous conduit (fig. 5). This channel was used primarily to drain the excess water from the bedrock (see above).

Pool 1 is located in the southern area of the garden and could have been part of the original plan, though this cannot be established with certainty (fig. 5). The pool, which was excavated but never published by Aharoni, was rediscovered in a poor state of preservation, and filled with refuse from the previous expedition. It is 1.8 meters deep, 2.4 meters wide and 2.5 meters long. The walls of the pool still bear the marks of plastering, and its floor is comprised of smoothed rock. The pool was connected to Channel A (see above) through Gutter 1. It is possible that Pool 1 was built in a later phase, and not as part of the original garden, as can be seen in the different style in its construction as compared to Pools 2 and 6, e.g., the floor building technique, the relatively poor masonry and the low quality plaster.

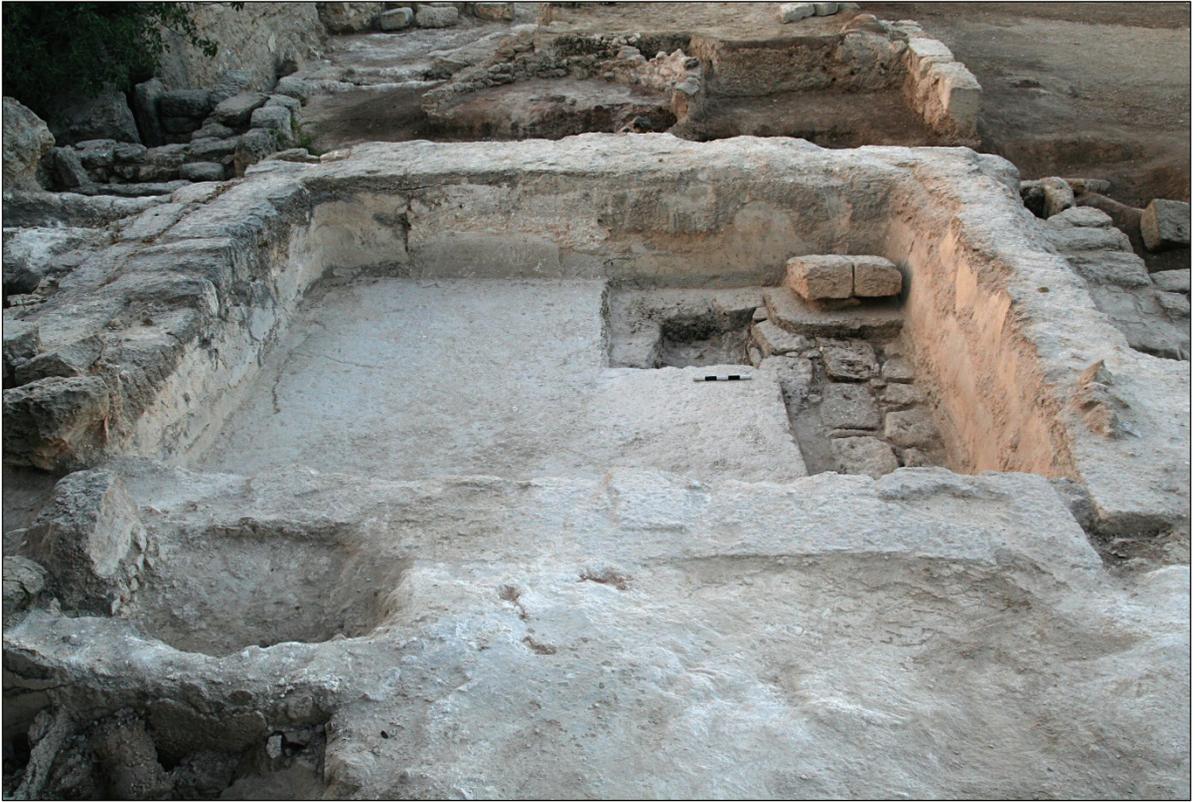
Fig.: Pool 2, looking south (picture by Noga Cohen-Aloro).

Pool 2: This pool is the most dominant, best preserved architectural feature in the southern part of the garden. The pool's walls were built of well-crafted ashlar blocks, 0.8-1.35 meters wide (the latter being the maximum width of the walls). The walls were covered by a thick layer of strong, homogenous plaster, 0.025 m thick in some places (fig. 6). Several layers of plaster were discerned, indicating repeated maintenance of the pool. The floor is a rare example of masonry and attention to quality and detail: A section of the floor indicates that it was built of large, flat, ashlar blocks fitted together. On top of the stone base, a thick layer (0.2 meters) of hard plaster was cast. The corners, where the floor touches the walls, were smoothed and rounded for a perfect finish. The high craftsmanship displayed in the construction of Pool 2 enabled the excellent preservation state in which it was found.

The pool is 1.1 meters deep, and could hold up to 35 cubic meters of water. Considering the lack of any other water source (see above), it is assumed that the pool was fed by rain water that was siphoned and channeled throughout the site (and perhaps conveyed from rooftops via gutters). The pool elevation (see section plan fig. 7) above the garden surface indicates that it was used as the source of a water distribution system and fed other installations. This is further proven by the gutters found connecting to the pool (see Gutters 3 and 4, below).

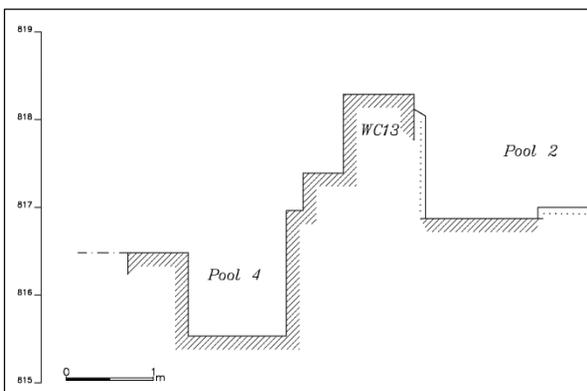
Fig. 7: Section plan of Pool 2 and smoothed bedrock, looking north (plan by Shatil Emmanuilov).

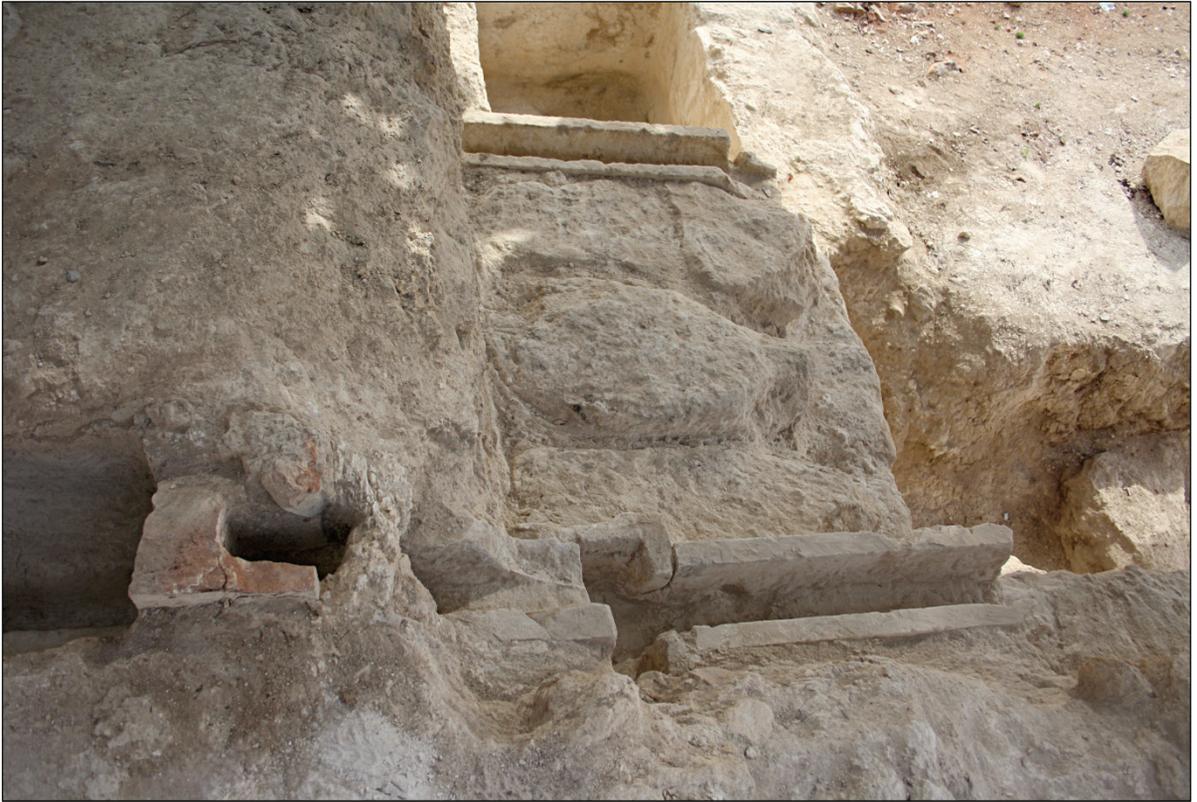
Fig. 8: Stone gutters (picture by Yuval Gadot).

Stone Gutters: Three stone gutters were found connected to Pool 2. Gutters 3 and 4 were open and masterfully carved out of a hard, bright white limestone (fig. 8). Gutter 2 is hewn and plastered.

flow in the gutter. As the western and eastern openings can easily be interpreted as controlling the water flow in Gutter 3, the top opening could have probably been used to connect an additional gutter that collected rain water, or as the opening for a slat used to dam the gutter (see fig. 8).

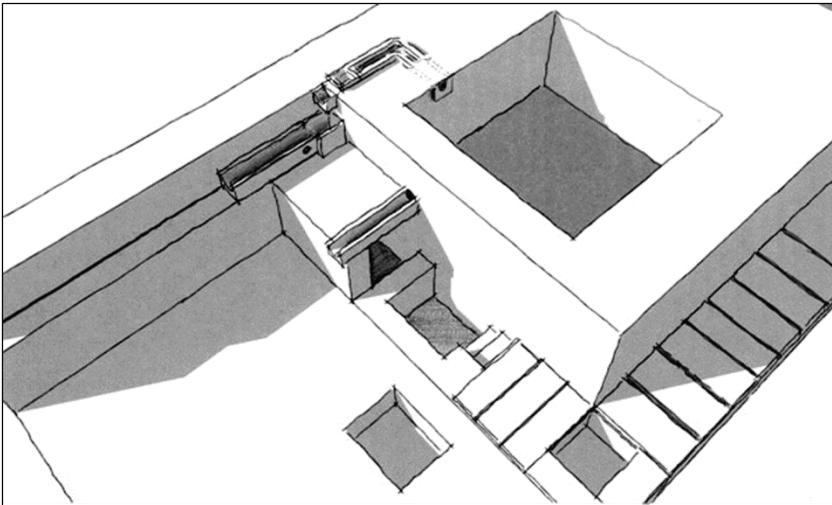
Fig. 9: Sketch of Pool 2 and stone gutters, looking northeast (drawing by Nirit Kedem).

Gutter 4 is embedded in the western wall of Pool 2 (fig. 9). It is located near the bottom of the pool and thus, in addition to providing irrigation, is likely to have served as a drain for the pool used during cleaning and maintenance. Its eastern part, 1.33 meters long, is embedded within the wall, evidence that the wall and the drain are contemporaneous, and built according to a pre-devised plan. The western part of the gutter protrudes 1.12 meters westwards of wall WC13, and is made of a single carved rock. The faces of the gutter are 0.05 meters thick and it is 0.13 meters deep. In its western part, the gutter rests on top of one

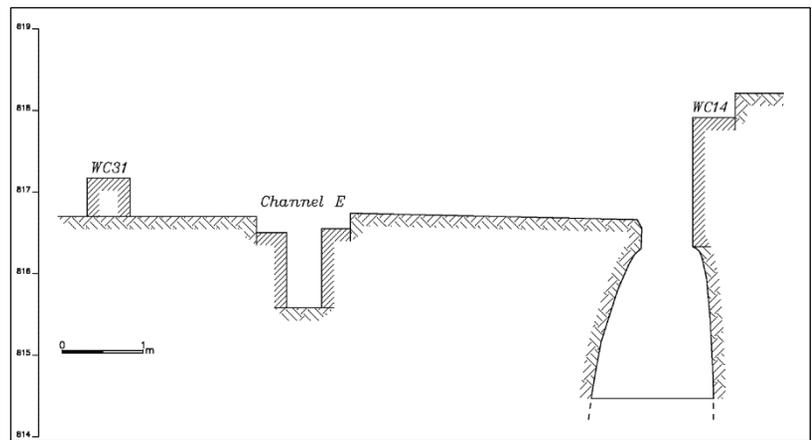
Fig. 10: Section plan of Channel E, looking north (plan by Shatil Emmanuilov).

Channel E continues the delineation of Channel D, beyond a collapse. It extends 13.5 meters farther in a straight line toward the southwest, ending at the southern scarp of the hewn complex. Here another niche was found, about 0.8 meters deep and 0.5 meters wide. The channel is 0.42 meters wide and 1.05 meters deep in its northern part and 0.48 wide and 0.7 meters deep in its southern part. Four roof slabs were found *in situ* and sections revealed the robbery trenches that were most likely created to salvage the well-cut stones.

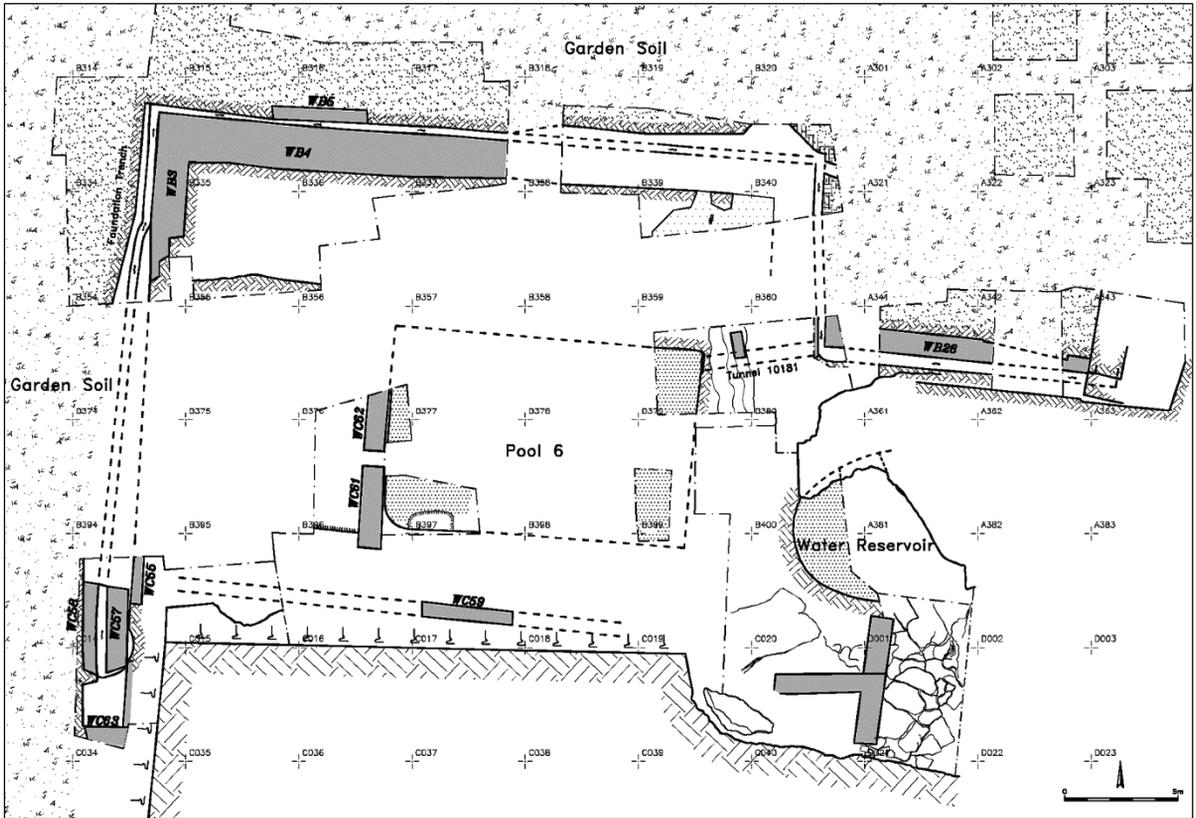
Fig. 11: Plan of the northwestern area (plan by Shatil Emmanuilov).

The extension of the palace itself was built of massive ashlar walls found inside deep, wide foundation trenches (fig. 11).

The open channel system stretches some 150 meters. In two locations differences in elevations could be discerned: In Square C34 (see fig. 11) a 2 meter drop, from south to north, occurs. In this area the channel and the architecture around it are poorly preserved, making it difficult to understand their exact function. We assume that here the water either dropped down as a waterfall, or funneled down through a vertical drain.

Pool 6 is a large plastered pool located north of the rock outcrop (fig. 11). It is 9 meters wide and 13.5 meters long. Its maximum depth may have been 2.5 meters, making its volume about 300 cubic meters. Pool 6 is the largest water reservoir in garden complex.

The Water Reservoir is a large plastered cavity that was exposed in the northwestern part of the site under the massive pieces of the cave's roof (fig. 11). This reservoir had been in use until the Roman period, when the cave roof collapsed. The complete contour of the reservoir was not exposed, but based on the excavated part we know that it was at least 6 meters in diameter, and about 3.5 meters

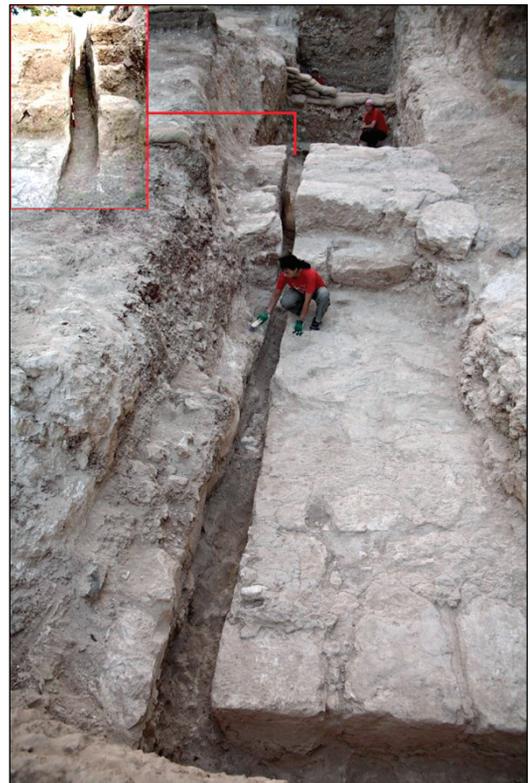
Fig. 12: Open water channels, looking east (picture by Pavel Shrago).

The channels are about 0.3 meters wide and up to 2.6 meters deep (fig. 12). They were usually installed between two walls: on one side, the massive ashlar wall, and on the other, a small wall that supported the rock face of the foundation trench. Only in places where the rock seemed solid enough, the channel ran between the ashlar wall and the plastered rock face.

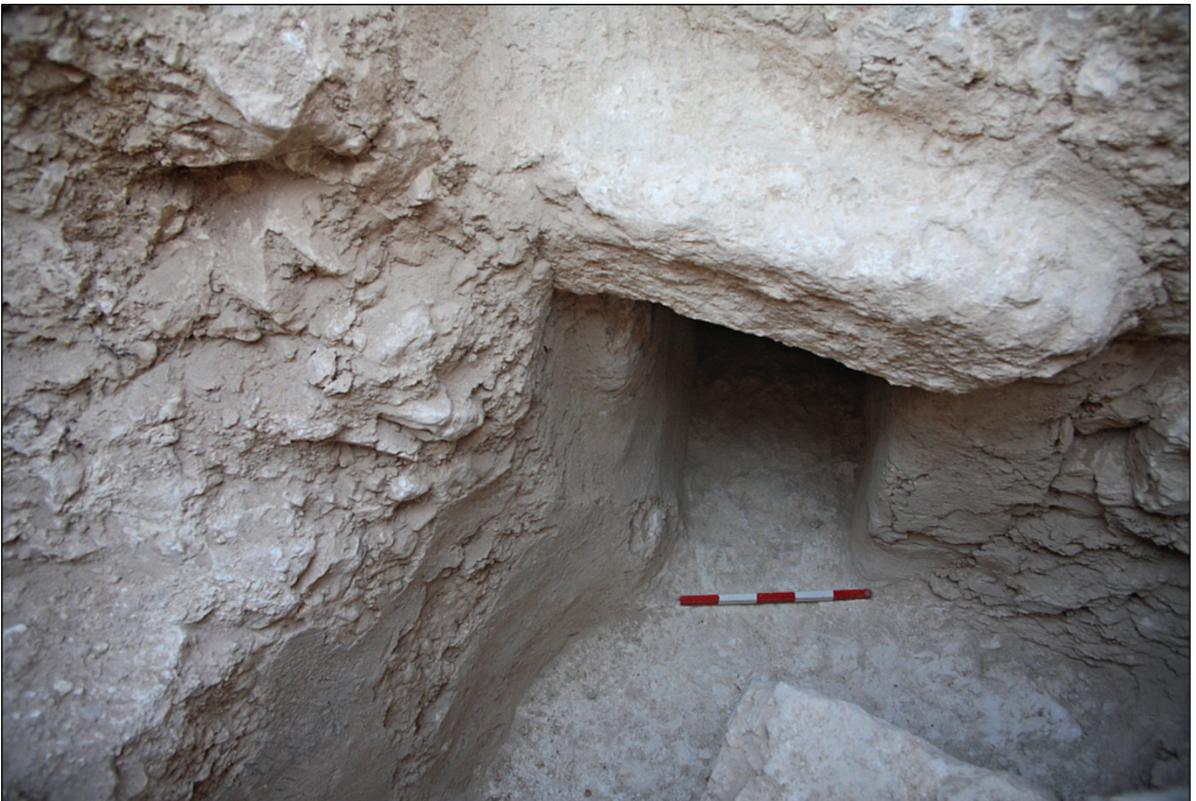
Fig. 13: Roofed tunnel, looking southwest (picture by Pavel Shrago).

To the west, the channel continued into a hewn tunnel covered with stone slabs. The tunnel is 4.5 meters long, 0.51 meters wide and 1.29 meters high (fig. 13). The building technique utilized in the creation of the tunnel is unclear, but it seems that the tunnel was hewn horizontally in a 'T' shape, and then the slabs were inserted into the wide part – probably to support the unstable limestone above. The tunnel was thoroughly plastered. At its western end, a rectangular stone device was found embedded in the rock face that included a cone-shaped, westward-oriented drilled hole. It is possible this device regulated the flow of water into Pool 6 (see below) to the west.

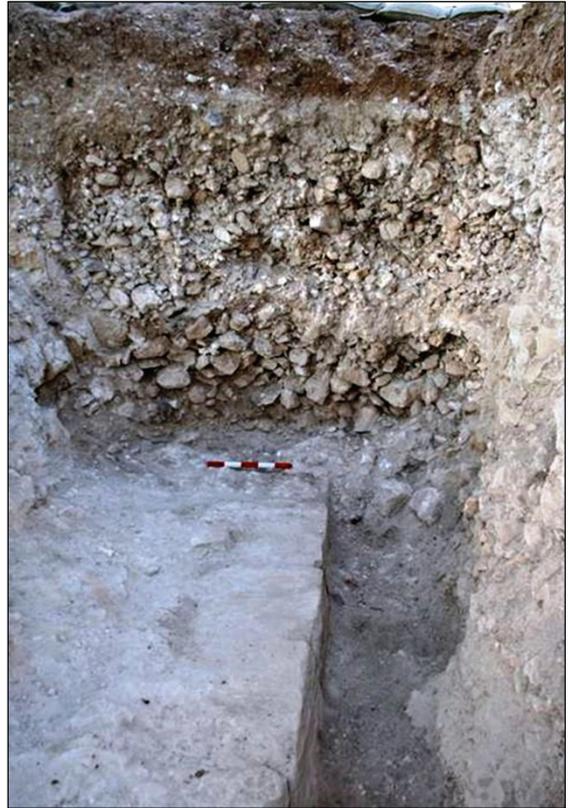
Fig. 14: Fill inside the foundation trenches, looking south (picture by Oded Lipschits).

The open water channels and the impressive architecture surrounding them likely fell out of use during the Hellenistic period when the walls were dismantled and the empty trenches were filled with a homogeneous layer of fill containing large numbers of pottery sherds and small stones (fig. 14). It is likely that the fill originated in dump piles that accumulated at the site during the time it was inhabited, as it includes sherds dating to the late Iron Age to the Hellenistic period. Pottery from later periods was only found in places where later burials penetrated the fill.

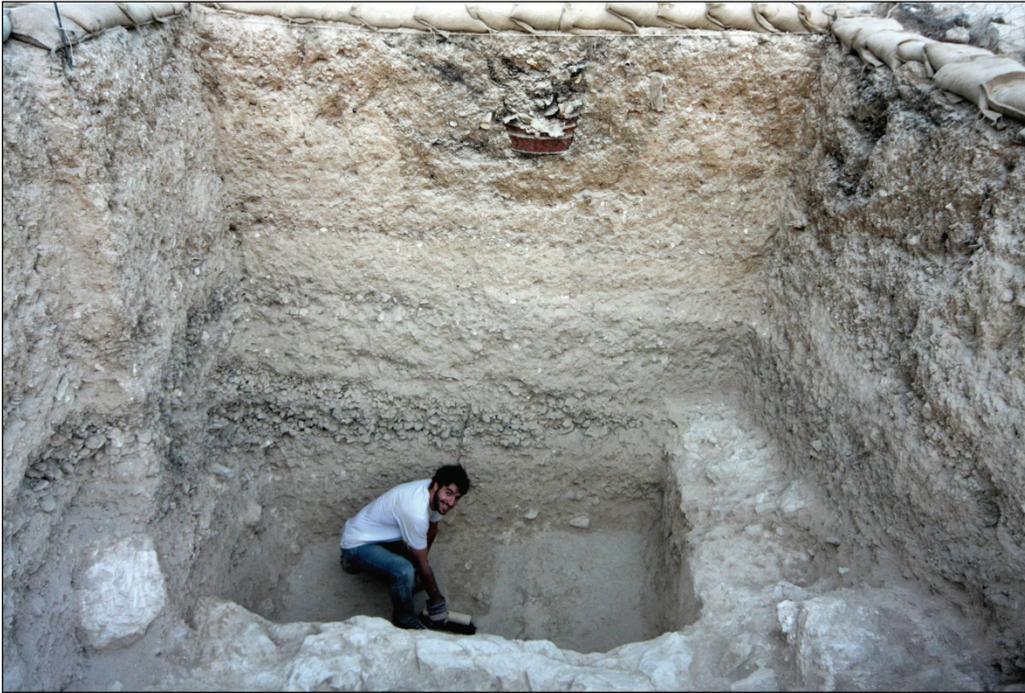
Fig. 15: Accumulation layers inside Pool 6, looking west (picture by Pavel Shargo).

After the opening between Pool 6 and the tunnel to its east (see above) was plastered over, the pool was disconnected from the rest of the water system, but continued to function independently. When the pool was finally taken out of use it was not filled with the same material as the rest of the surrounding foundation trenches, but was simply abandoned, gradually being filled by the silt and earth that

eroded from the cliff to the south (fig. 15). The pottery in these layers was dated from the late

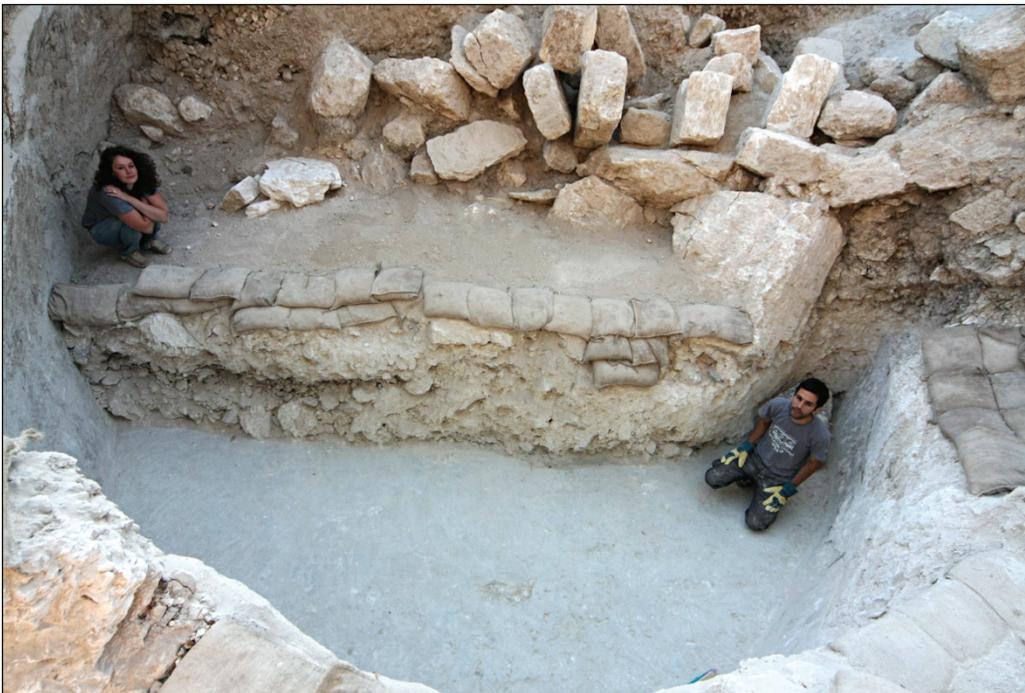
Fig. 16: The water reservoir, looking east (picture by Pavel Shrago).

deep. We can calculate a minimum of 100 cubic meters of water that could have been stored in the reservoir (fig. 16), making it one of the largest water installations at the site. The reservoir was filled via a round opening in its roof (already discovered by Aharoni; 1964: 55), and a series of hewn trenches leading to it, still visible to its east.
